Manhole Inspection Summary

Manhole # S41K__051MH

Record Plat: **41K** Node: **051** Status: **New Manhole (Not in GIS)** Insp Date: **5/23/08 12:00 AM**

Location Address: **front of 1432 spring caroline alley** Cross Street: **fleet st**

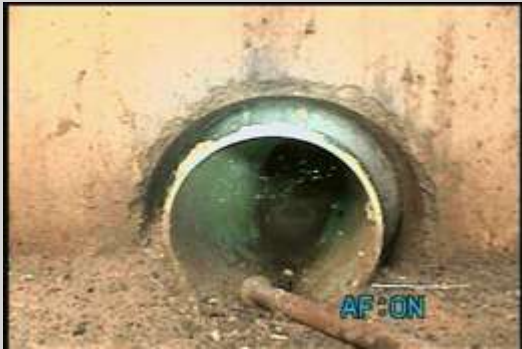
12 O'Clock Outflow

8 in. Circular Gravity Sewer
Pipe Out @ 12 O'Clock

Pipe Material: **PVC** ☐ Pipe Lined

Invert Depth: **9.74** (ft.) Flow Characteristics: **Slow**

Deposits: ☒ None ☐ Mud ☐ Sludge ☐ Debris ☐ Grease

Infiltration: **None**
